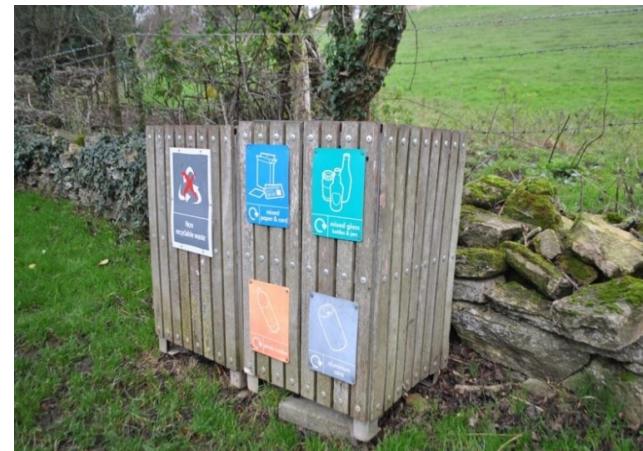
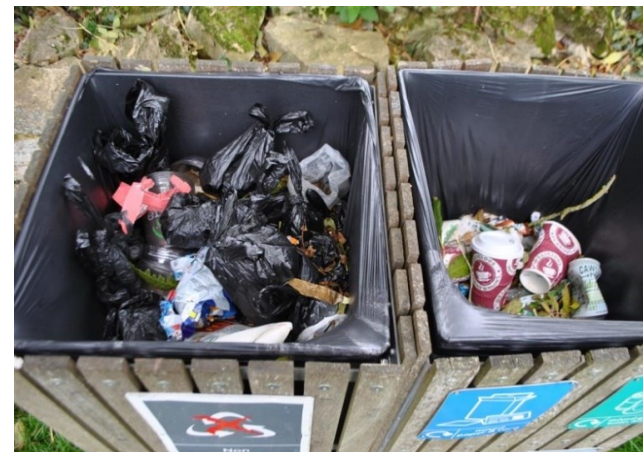
Asset No.	WB/001
Location	Freshford Village Hall Playing Field
Inscription	None
OS Grid Reference	784601
Size	
Description	Timber clad waste Bin
Construction	Timber clad waste Bin
Condition	Good
Life expectancy	10 years
Recommended repairs	Repair And recoat in 2018.
Cost

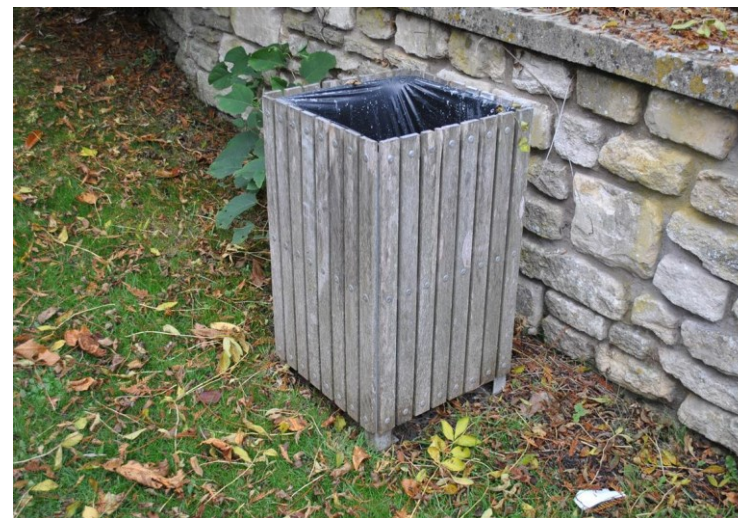
Asset No.	WB/002
Location	Freshford Village Hall/Freshford Lane
Inscription	None
OS Grid Reference	784600
Size	
Description	Timber clad waste Bin
Construction	Timber clad waste Bin
Condition	Good
Life expectancy	10 years
Recommended repairs	Repair And recoat in 2018.
Cost

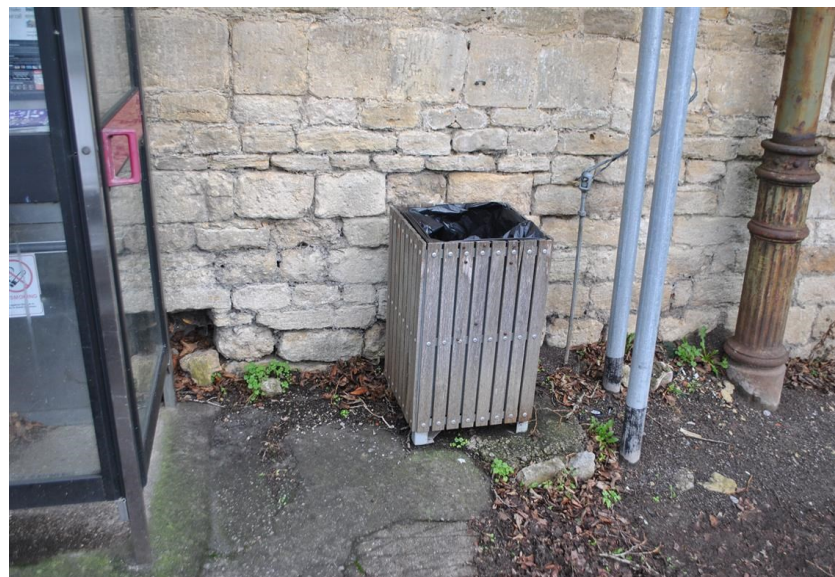
Asset No.	WB/003
Location	Church Hill/Hill
Inscription	None
OS Grid Reference	789601
Size	
Description	Timber clad waste Bin
Construction	Timber clad waste Bin
Condition	Good
Life expectancy	10 years
Recommended repairs	Repair And recoat in 2018.
Cost

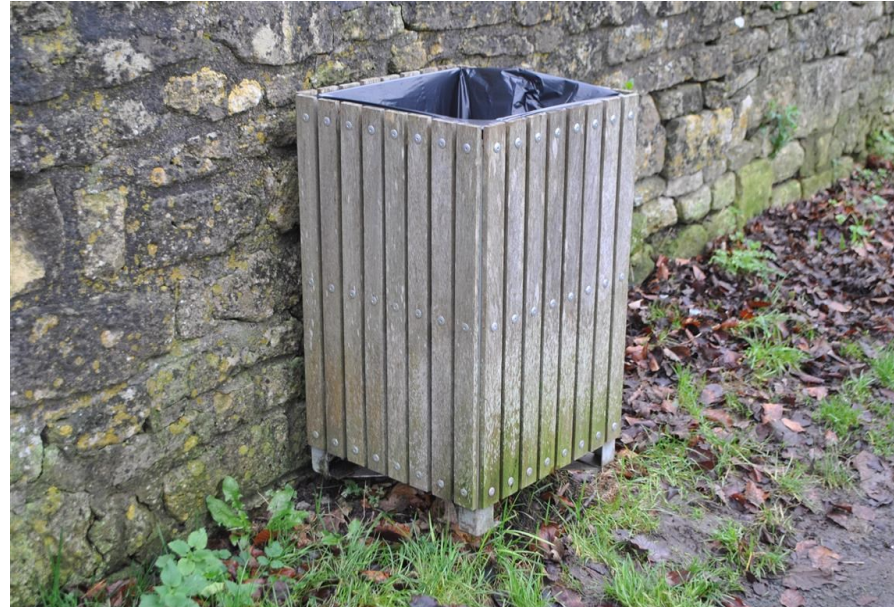
Asset No.	WB/004
Location	Tyning East
Inscription	None
OS Grid Reference	788600
Size	
Description	Timber clad waste Bin
Construction	Timber clad waste Bin
Condition	Good
Life expectancy	10 years
Recommended repairs	Repair And recoat in 2018.
Cost

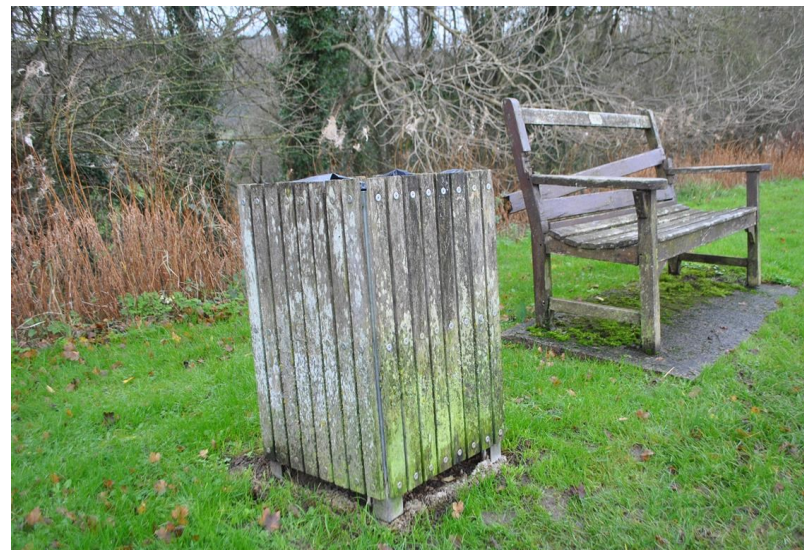
Asset No.	WB/005
Location	Tynning Centre
Inscription	None
OS Grid Reference	787599
Size	
Description	Timber clad waste Bin
Construction	Timber clad waste Bin
Condition	Good
Life expectancy	10 years
Recommended repairs	Repair And recoat in 2018.
Cost

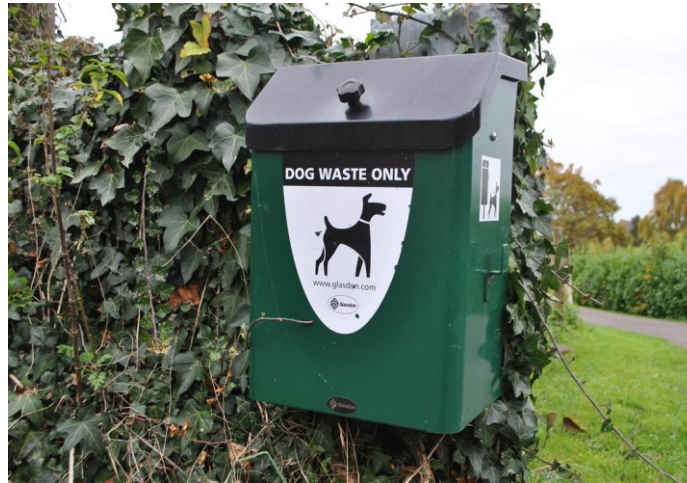
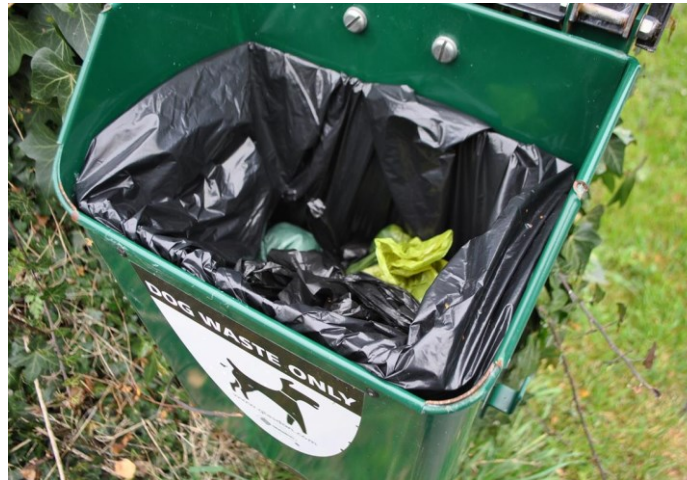
Asset No. WB/006  
Location Dog Bin Ashes Lane  
Inscription None  
OS Grid Reference 781599  
Size  
Description BANES metal box.

Construction  
Condition Good  
Life expectancy 10 years  
Recommended repairs None
